## **Bellhousing Alignment for Your LGT-700 Transmission Warranty**

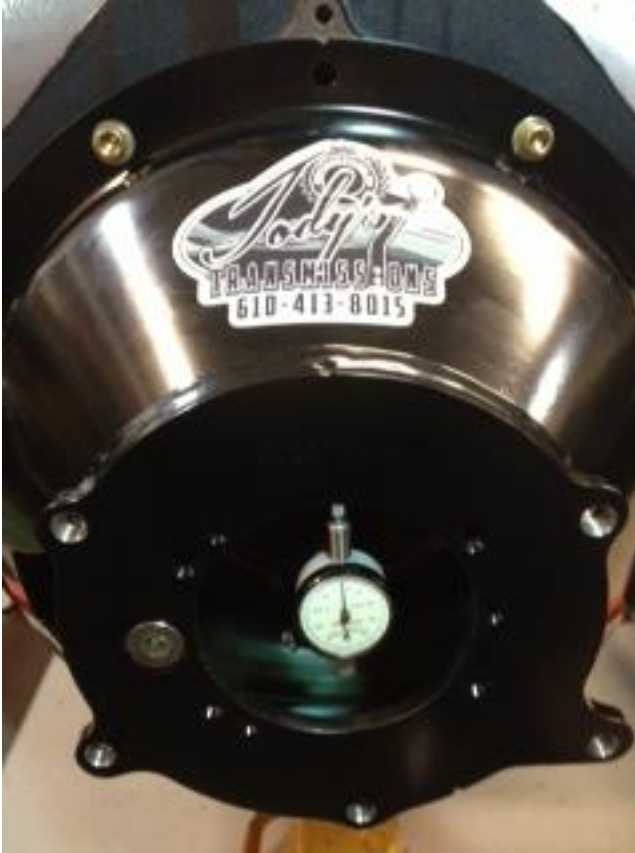
*figure 1*

2. With the engine on TDC (Top Dead Center), install the dial indicator base on the flywheel. Adjusting the plunger to contact the inside edge of the bellhousing transmission register hole at 12:00. If needed, removing two flywheel bolts 180° apart for the dial indicator to sit flush on the flywheel is OK. **see figure 1**

3. With the dial indicator on (0) zero and mounted securely at 12:00, your helper can rotate the crankshaft 360° slowly. Your job is to note the dial indicator reading, you are looking for the most (-) negative number on the dial indicator as it rotates the 360°. When your helper rotating the crankshaft stops on TDC, your dial indicator should read (0) zero at 12:00. If you read (0) zero, then you have verified your dial indicator is mounted securely. Do another crankshaft rotation to double check your dial indicator still reads (0) zero at 12:00.
4. With the dial indicator still secured at 12:00; note the most (-) negative number of the dial indicator during your next 360° rotations. Once you are certain where the most (-) negative number is, mark the bellhousing. This most (-) negative number will be your new dial indicator (0) zero location.

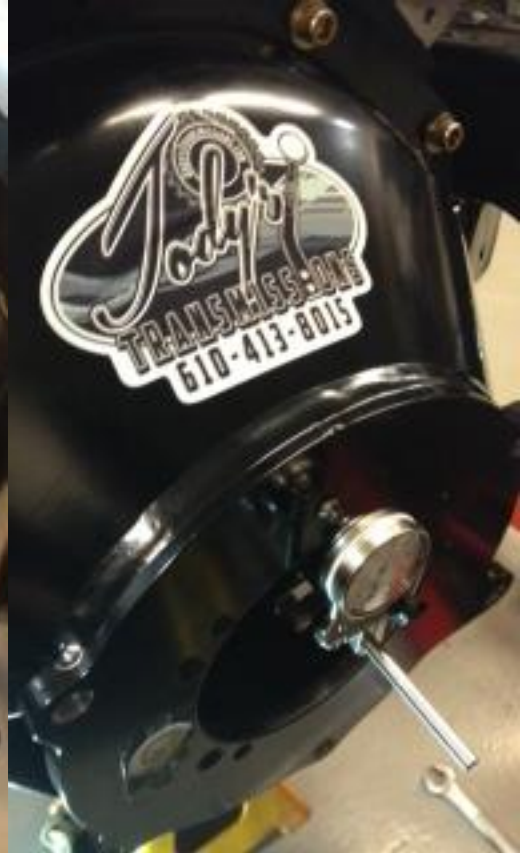
*figure 2*

1. With the engine on TDC and the dial indicator base still mounted on the flywheel, adjust the plunger to contact the front face of the bellhousing at 12:00. **see figure 2**

**Note:** The bellhousing front face is the contact area your transmission mounts to. You can add a piece of packaging tape to cover the clutch fork pivotball threaded hole. The packaging tape will also allow the plunger to glide over the hole opening.

2. With the dial indicator on (0) zero and mounted securely at 12:00, your helper can rotate the crankshaft 360° slowly. As before, your job is to note the dial indicator reading, you are looking for the most (-) negative number on the dial indicator as it rotates the 360°. When your helper rotating the crankshaft stops on TDC, your dial indicator should read (0) zero at 12:00. If you read (0) zero, then you have verified your dial indicator is mounted securely. Do another crankshaft rotation to double check your dial indicator still reads (0) zero at 12:00.
